LAKE TIORATI DAM
PHASE I INSPECTION REPORT
NATIONAL DAM SAFETY PROGRAM

NY 00043

Name of Dam: Lake Tiorati Dam
County and State: Orange County, State of New York
Inventory Number: NY 43

Date: July 26, 1978

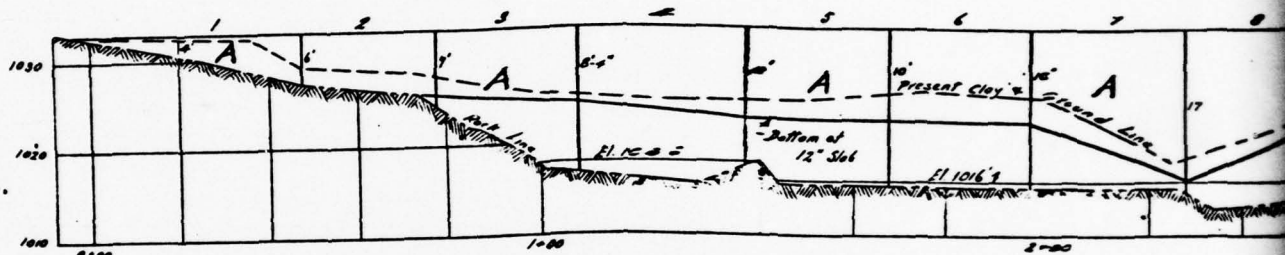
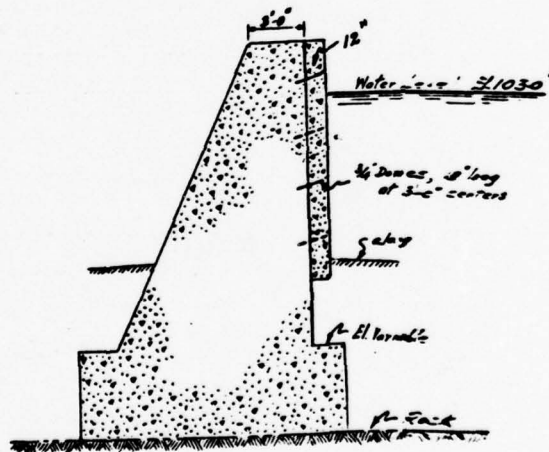
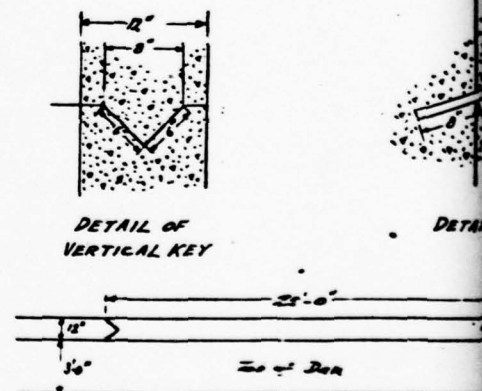
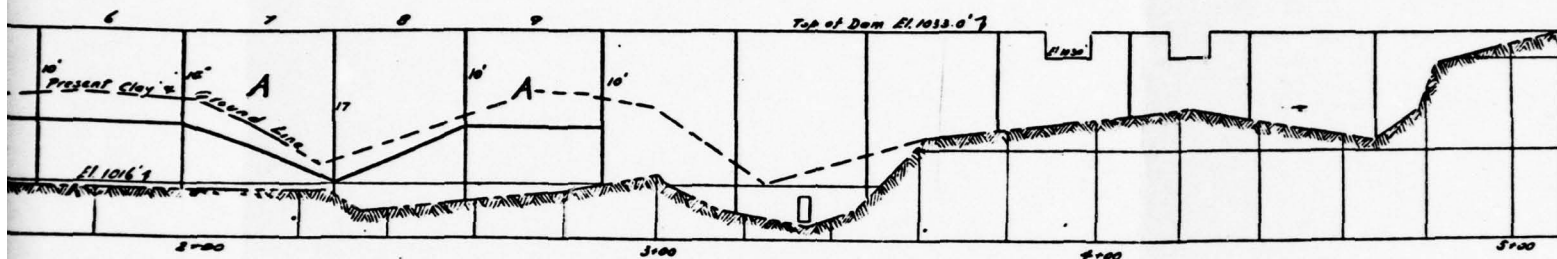
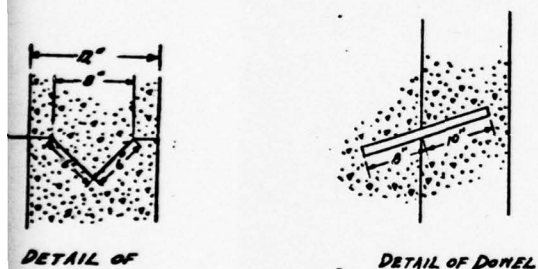
FIGURE 5

NOTE: SECTIONS MARKED "A" ARE WHERE
 CONCRETE WAS AFFECTED BY FROST
 ACTION IN ORIGINAL DAM

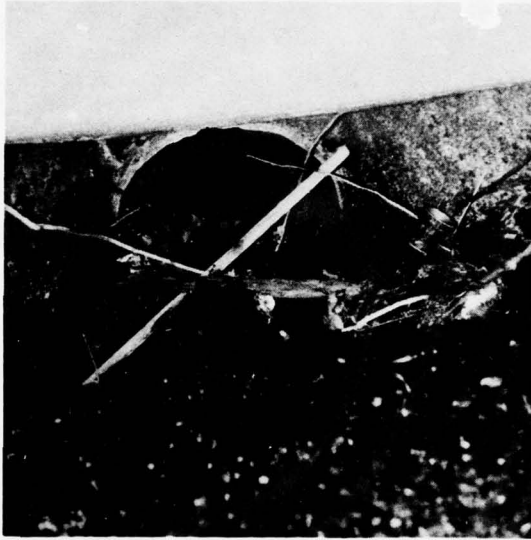
DEBRIS IN UPSTREAM CONDUIT OPENING

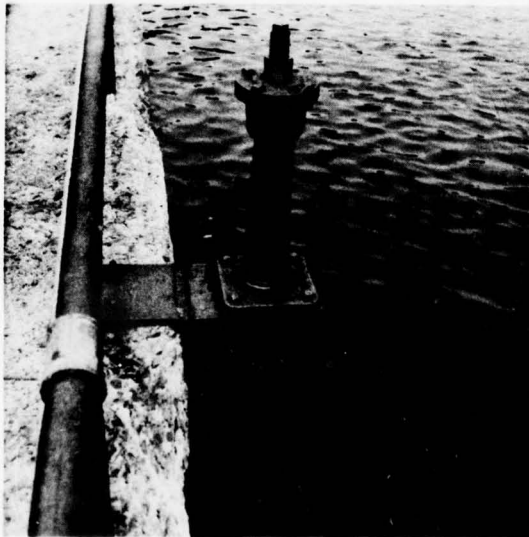
d. Outlet Works - There are no operational outlet works for the dam. The original sluice gate does not appear to be operable, and the downstream end of its outlet conduit is buried under the roadway fill.

No operable means of drawdown is available at the Lake Tiorati Dam. The placement of the earth embankment on the downstream face has buried the outlet through the concrete structure. A sluice gate is shown on the plans, and the stem was observed during the field inspection. It is reported that the mechanism is not operable.

OPERATING MECHANISM OF SLUICE GATE
